## High School – Roof Repair & Restoration

## Mt. Rock Elementary – Partial Roof Replacement

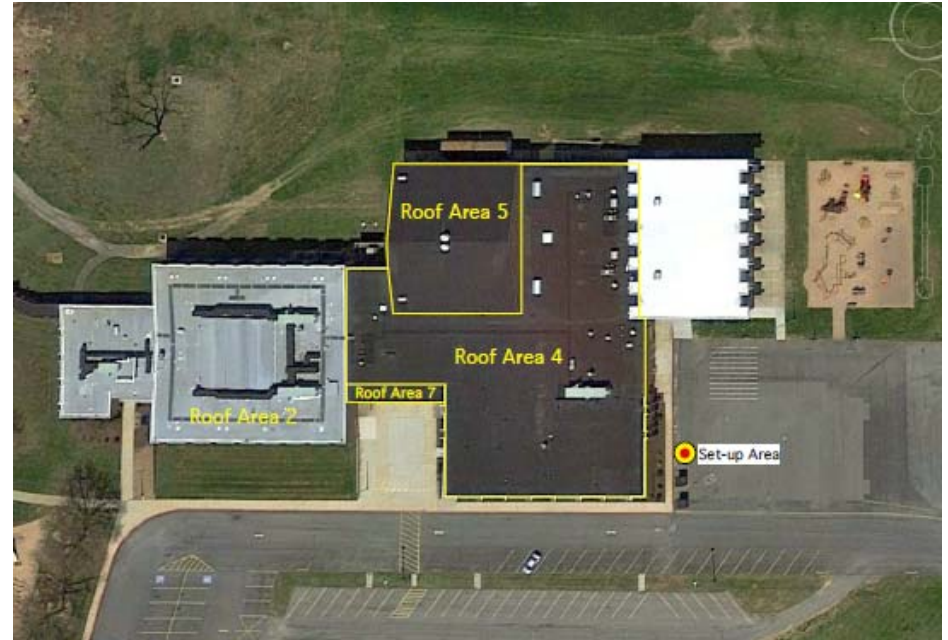
- Roofs will be removed to the metal decks.
- Capped curbs will be removed on Roof Area 4.
- Vapor barriers will be installed on the metal deck on Roof Areas 4 and 5. Currently there is not one in place. This will stop the vapor drive within the building from entering the roof system.
- 5/8 inch Fire Rated cover board will be installed over the vapor barrier. Currently there is not fire barrier within the existing assembly. This qualifies for a Class A interior fire rating.
- 3.5 inches of polyisocyanurate insulation will be installed on Roof Areas 4 and 5. Roof Area 7 will receive tapered insulation. Polyisocyanurate insulation will be overlaid with a ¼ inch layer of Securock insulation.

- Roofing system – Two plies of modified membrane will be installed in cold adhesive with a flood and gravel surface. Since the deck is dead level flat and tapered insulation cannot be used economically since the perimeter counterflashings will have to be raised on the masonry walls.
- Perimeter and projection flashings will be a two-ply construction.
- Edge metal will have a 215 MPH lifetime wind warranty.
- Interior drains will be replaced.
- Overflow scuppers will be installed along the north wall of Roof Area 4. Missing overflow scuppers of drains is a Code violation.
- The roof systems will have a 40-year warranty.
